1993 RIPARIAN MANAGEMENT ZONE SURVEY

TFW Field Implementation Committee

June 20, 1994

TFW FIELD IMPLEMENTATION COMMITTEE
RIPARIAN MANAGEMENT ZONE SURVEY

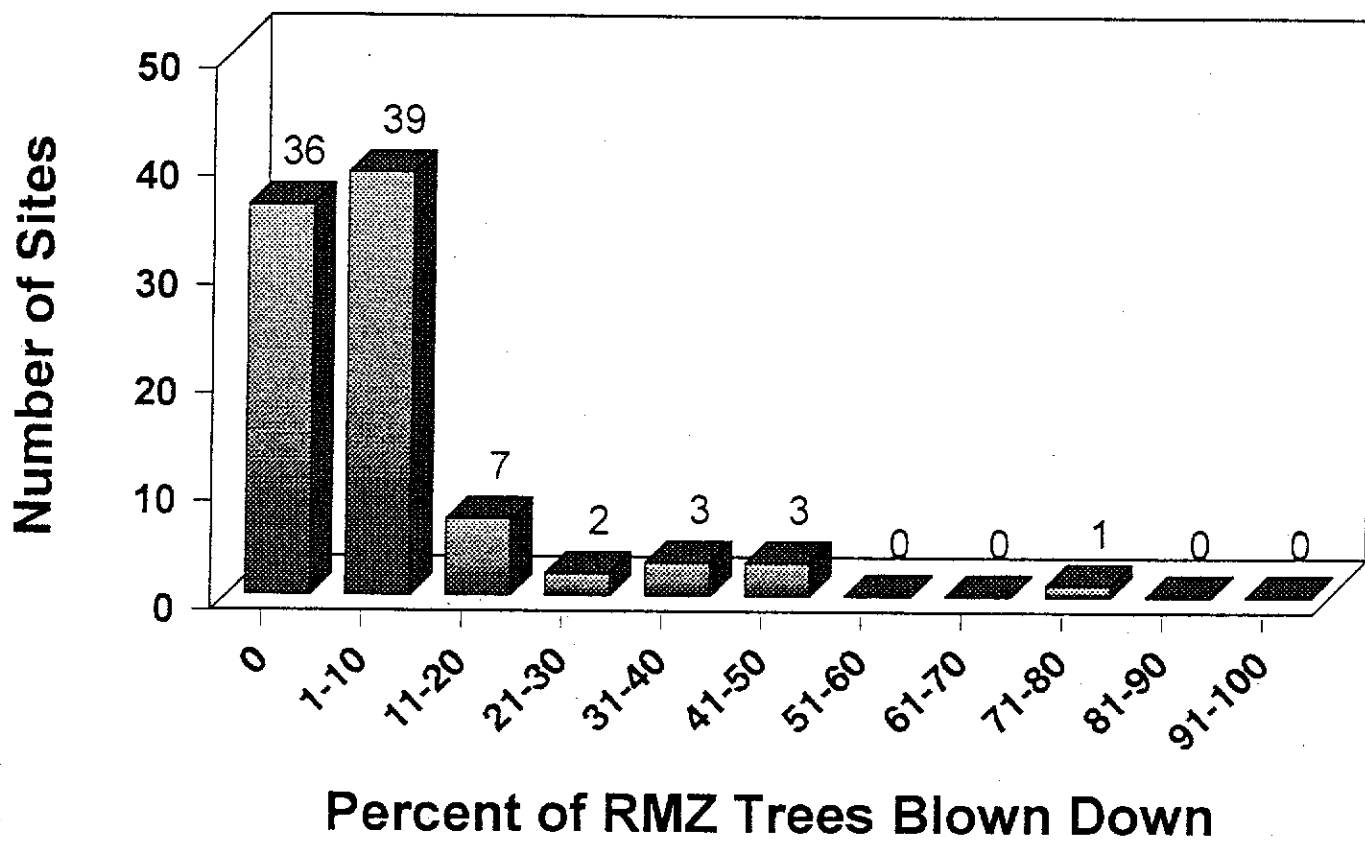
RMZ Blowdown Survey Results

The results of the blowdown survey are shown in Figure 1. In summary, 82% of the RMZs surveyed had 10% or less of the leave trees blown down. Only one site had more than 50% blowdown. Three of the 94 samples were not used in this blowdown summary. Two samples were recently harvested and did not meet time requirements necessary to qualify for inclusion. One sample had no information.
